Manhole Inspection Summary

Manhole # S13II1023MH

Insp Date: **6/13/07 1:24 PM**

Location Address: **PIMLICO RD**

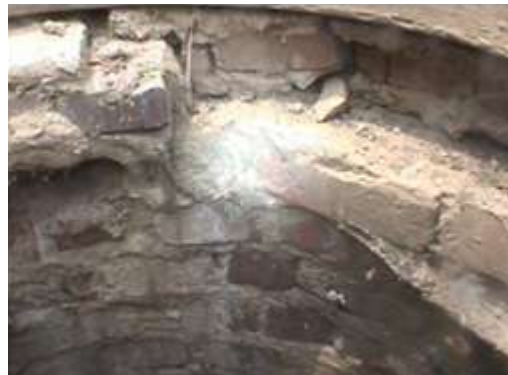
Defect 2

Condition: ☐ Sound ☐ Cracked ☐ Root Intrusion ☒ **Loose Brick** ☒ **Deteriorated**

DETERIORATED / LOOSE BRICKS-
CHIMNEY ADJ.

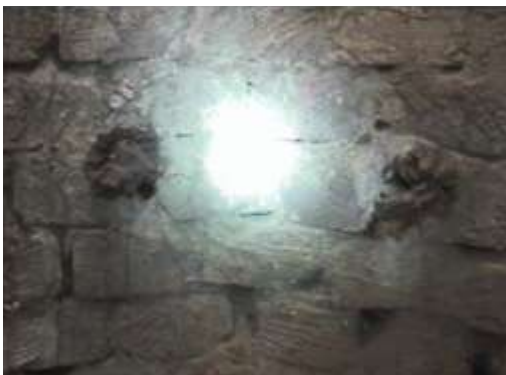
Defect 1

Count: **4** Missing: **1** ☒ **Corroded**

MISSING RUNG

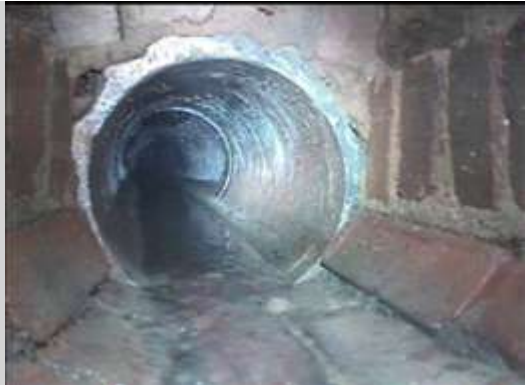
12 O'Clock Outflow

8 in. Circular Gravity Sewer
Pipe Out @ 12 O'Clock

Pipe Height: (in.) Direct
Pipe Material: **Clay** ☐ Pipe Lined
Invert Depth: **7.83** (ft.) Flow Characteristics: **Slow**
Deposits: ☒ None ☐ Mud ☐ Sludge ☐ **Debris** ☐ Grease
Silt Depth: (in.) Deposits Extent:
Infiltration: **None** Pipe Seal Cond: **Sound**

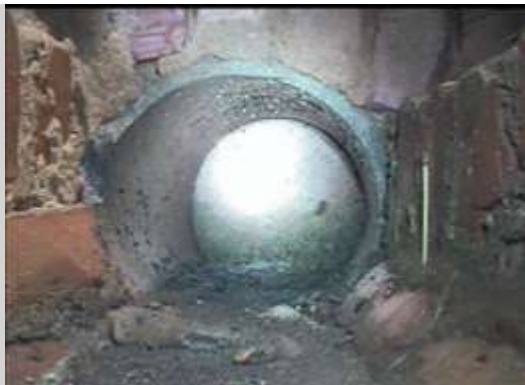
6 O'Clock Inflow

8 in. Circular Gravity Sewer
Pipe In @ 6 O'Clock

Pipe Height: (in.) Direct
Pipe Material: **Clay** ☐ Pipe Lined
Invert Depth: **7.81** (ft.) Flow Characteristics: **None**
Deposits: ☒ None ☐ Mud ☐ Sludge ☐ **Debris** ☐ Grease
Silt Depth: (in.) Deposits Extent:
Infiltration: **None** Pipe Seal Cond: **Sound**

Connects To: **Stub connection / abandoned**

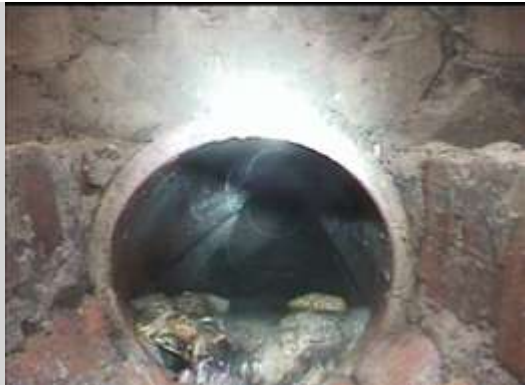
9 O'Clock Inflow

Deposits: ☐ None ☐ Mud ☐ Sludge ☒ **Debris** ☐ Grease

Silt Depth: **2** (in.) Deposits Extent: **Heavy**
